**Construction of Telugu-Ganga Canal in and around two
protected areas in Cuddapah District, Andhra Pradesh, India.
Immediate threat to the world population of the
critically endangered Jerdon's Courser *Rhinoptilus bitorquatus***

Survey Report, December 2005

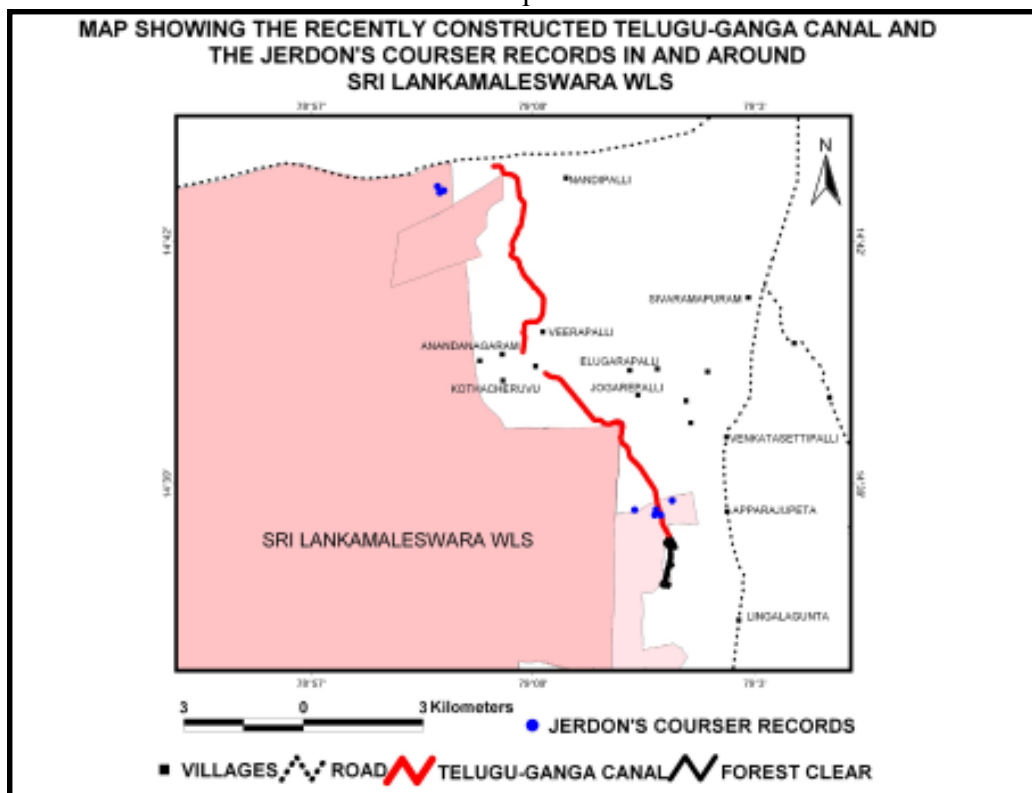
Map. 3

The Right Canal comes southwards from SPVB reservoir and ends 2 km away from Nandhipalli near Badvel - Mydukur road (Map 3). The total length of the canal upto this point is c.22 km. Canal excavation continues from the other end of the road for about 5.8 km till a place called Anandanagaram. It was learned from the local people that the canal was stopped there mainly because the owner of that land did not allow the construction since the compensation was not paid. The canal excavation continued again leaving the gap of about 800m from the previous canal. This goes for about 5.6 km and stopped inside the Yerraballi Forest block, Sidhout Range, Cuddapah

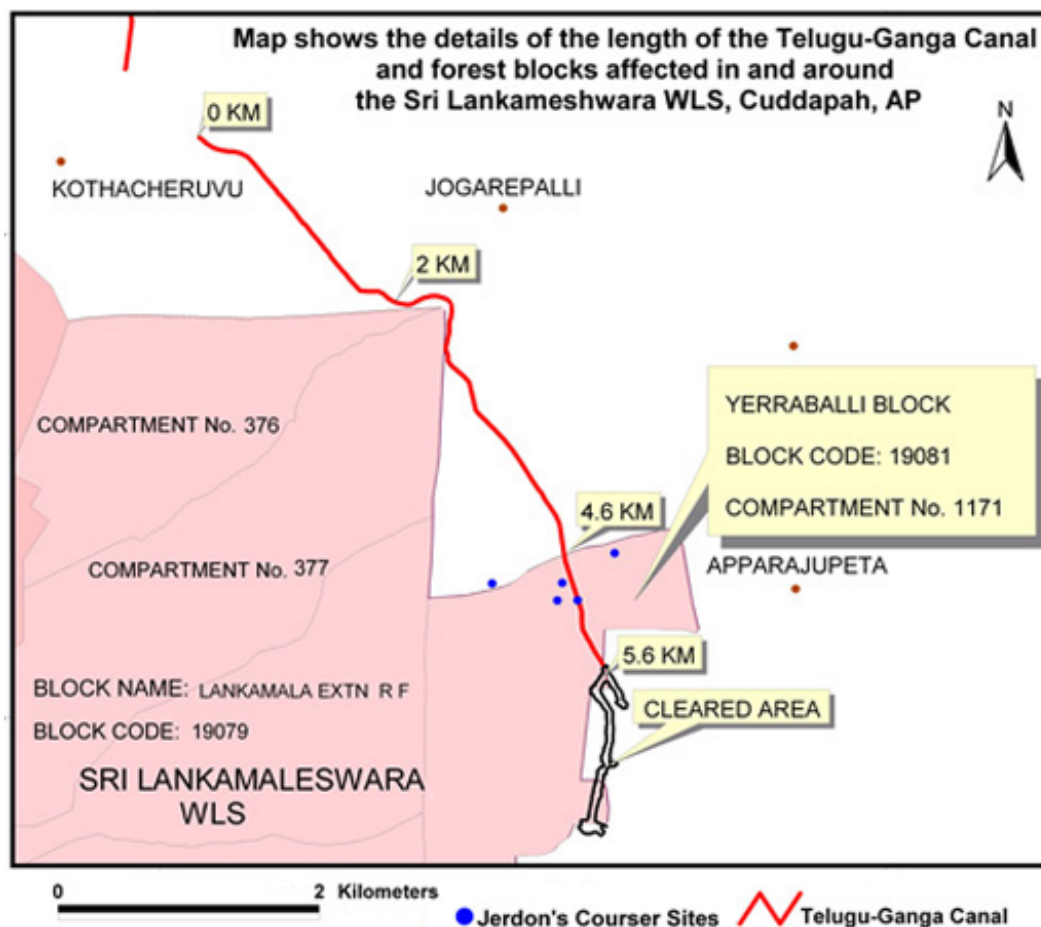
Map. 4

Forest Division. After 2 km from the starting point, it goes all along the Sanctuary boundary for about 1 km. After about 4.6 km, it enters into the Yerraballi Forest block and passes through the block for about 900m (Map 4 & Plate 1). Apart from this canal, forest area has been cleared for the construction of the canal in and around Yerraballi Forest Block. Total length of this clear is c.1.6 km.

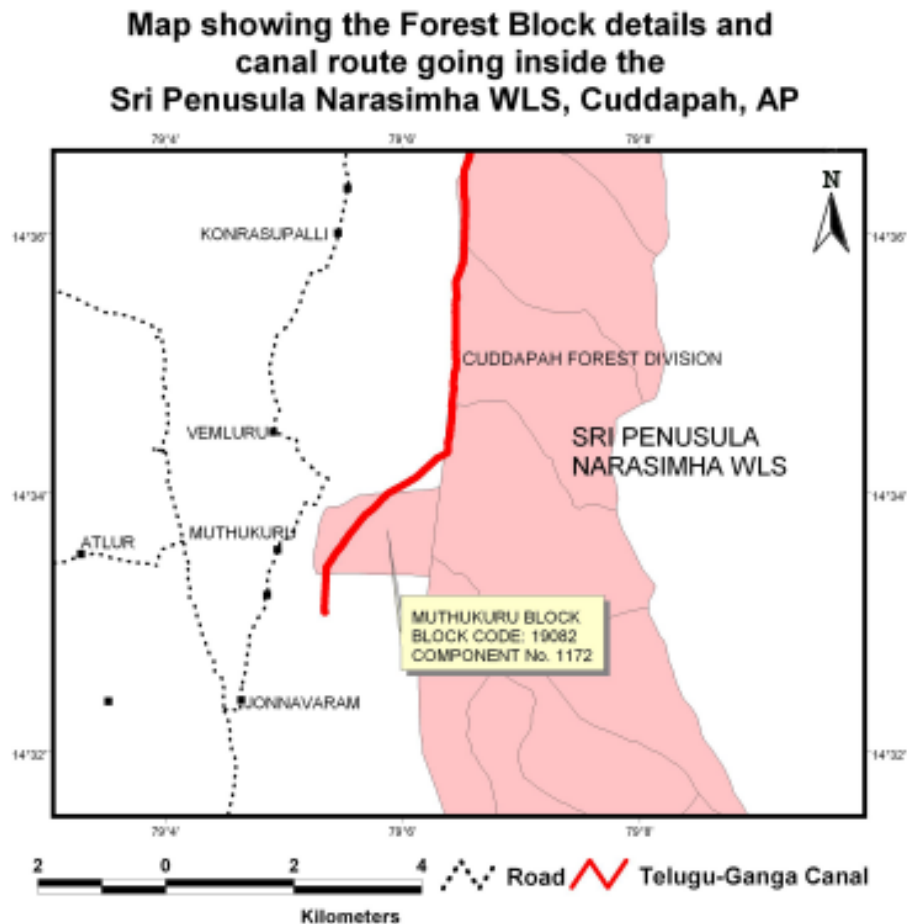
Map. 5

Madakaravarapalli is c. 23 km. The canal goes very close to the Sanctuary boundary. In some places forest has been cleared and roads were made inside the Sanctuary area. Also in many places forest cairns have been damaged (Plate 2). Finally the canal comes to an end near the place called Muthukur. While the canal reaches its 21st km it entered Muthukur Forest Block of the Sanctuary area which falls under Sidhout Range, Cuddapah Forest Division. Length of the canal construction inside this Forest Block is about 2 km (Map 5).

It should be noted that since the construction was done without obtaining the permission from the APFD, it was stopped by the Cuddapah DFO and concerned persons were arrested on 25th October 2005.

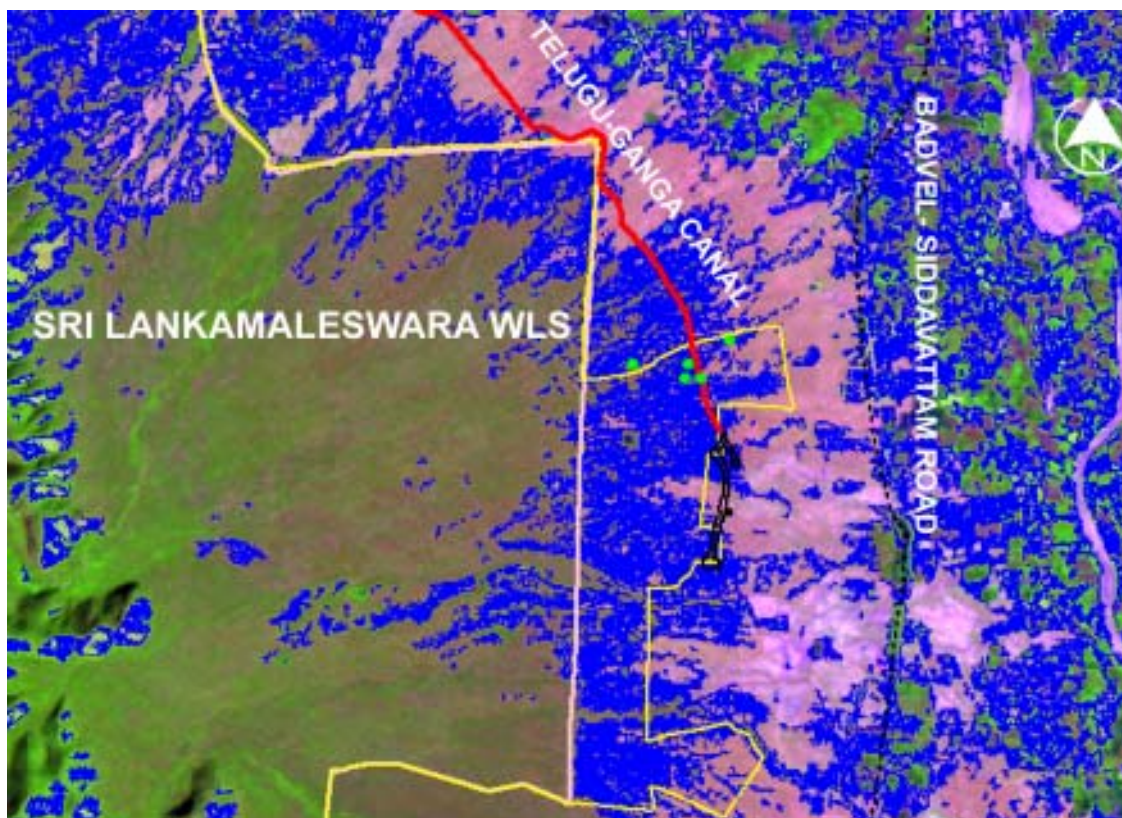
Map. 6. shows Landsat 7 ETM image of the study area with the preliminary habitat suitability map overlaid onto it. Note that extensive favorable habitat (in blue color) for the Jerdon's Courser found in the Yerraballi Forest Block. Green dots indicates Jerdon's Courser records and Black line indicate the cleared forest area.(Map not to scale).

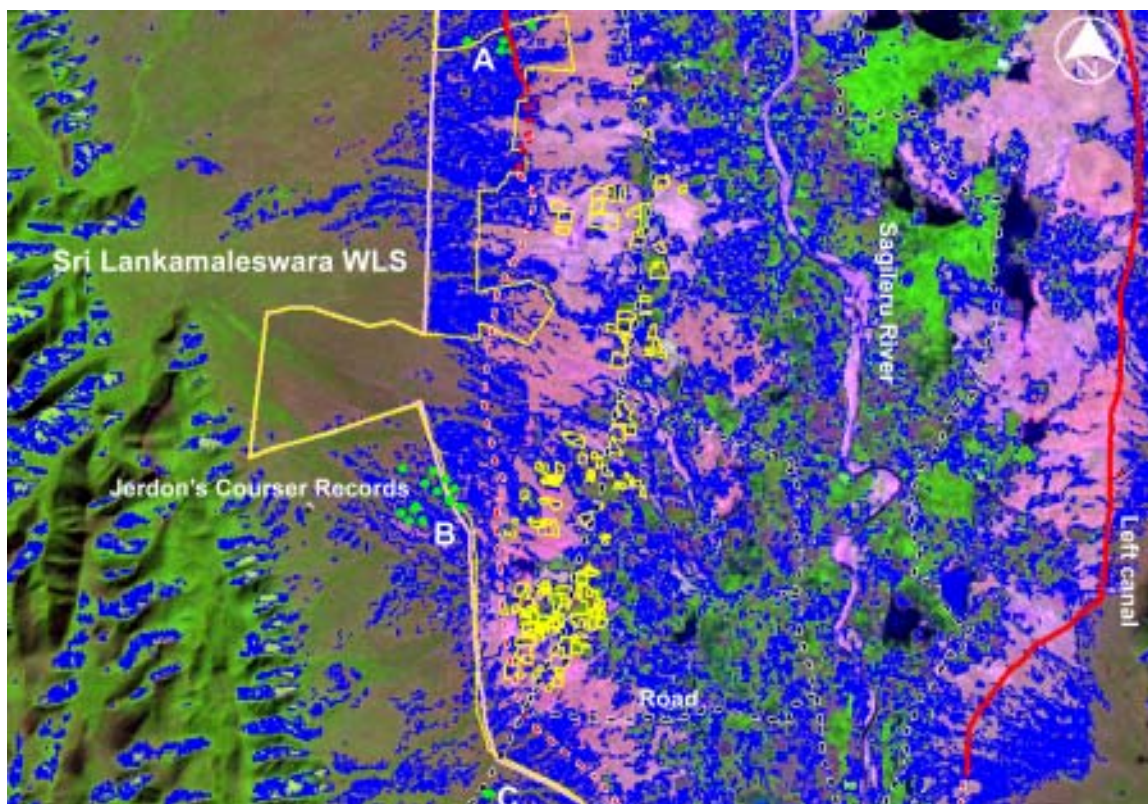
It was estimated that if excavations for the proposed canal progress further they will destroy c.50 ha of suitable habitat of the Jerdon's Courser around the Sri Lankamaleswara Wildlife Sanctuary (Map 7).

Map. 7. shows Landsat 7 ETM image of the study area with the preliminary habitat suitability map overlaid onto it. Green dots with A, B & C marks indicates recent Jerdon's Courser records and Red dotted line indicate the proposed route of the canal. Yellow lines indicates the lemon farms. (Map not to scale).

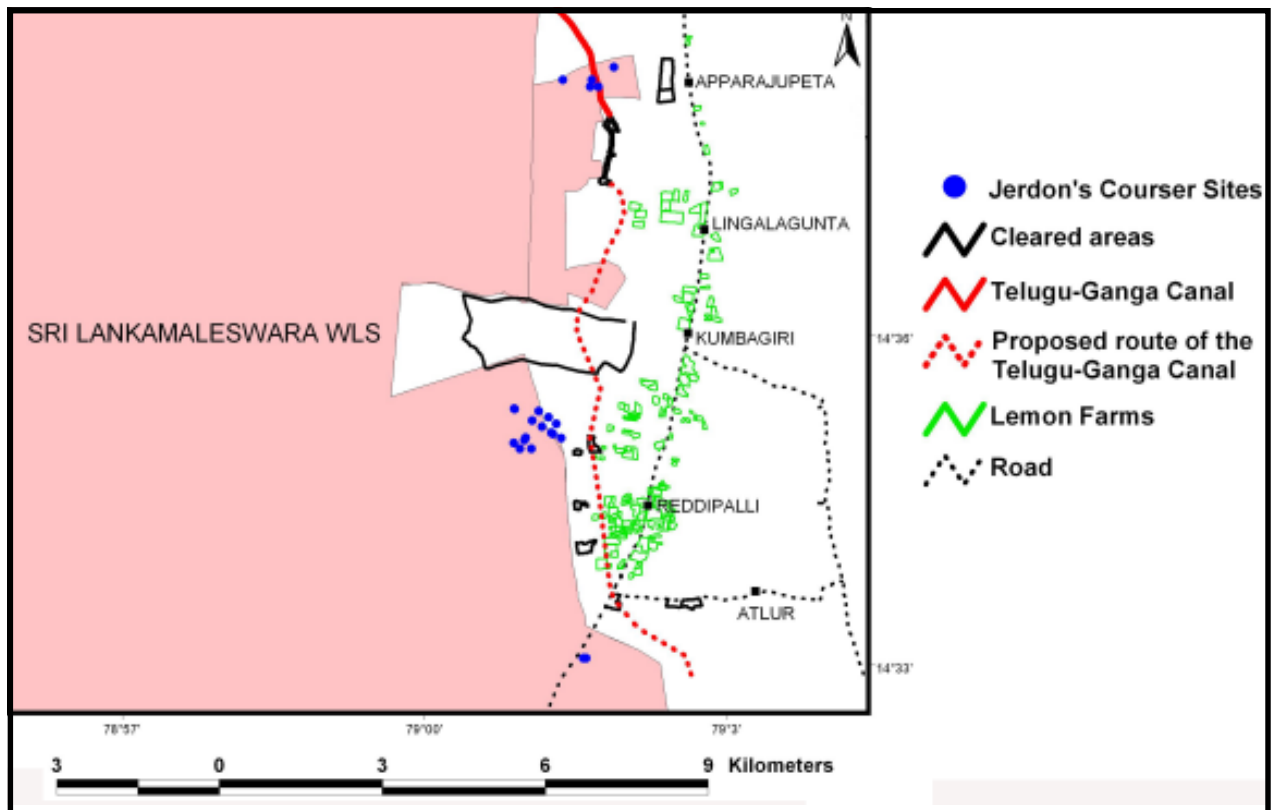
2. The canal will permit the extension of irrigated agriculture to many areas outside the Sanctuary that are scrub jungle at present. Rapid replacements of forested landscapes by cultivated lands along with the change in cropping pattern has deteriorated the Jerdon's Courser's habitat. Major crops of this place were paddy, cotton and sunflower. But in recent times, these have been replaced by sweet lime and lemon farms as they need relatively less maintenance, and are lucrative. This has resulted in the clearing of the scrub jungle areas outside the Sanctuary. Scrub jungle will be cleared for this purpose and this will remove Jerdon's Courser habitat and diminish the population. Scrub jungle has already been cleared for agriculture up to the Sanctuary boundary in several places since 2001 (Map 8).

Map.8. shows the proposed route of the Telugu-Ganga Canal and other cleared areas (mapped from 2001-04) in and around the Sri Lankamaleswar WLS. Note that all the cleared areas mainly for lemon farms falls very close to the sanctuary boundary as well as to the Jerdon's Couser sites.

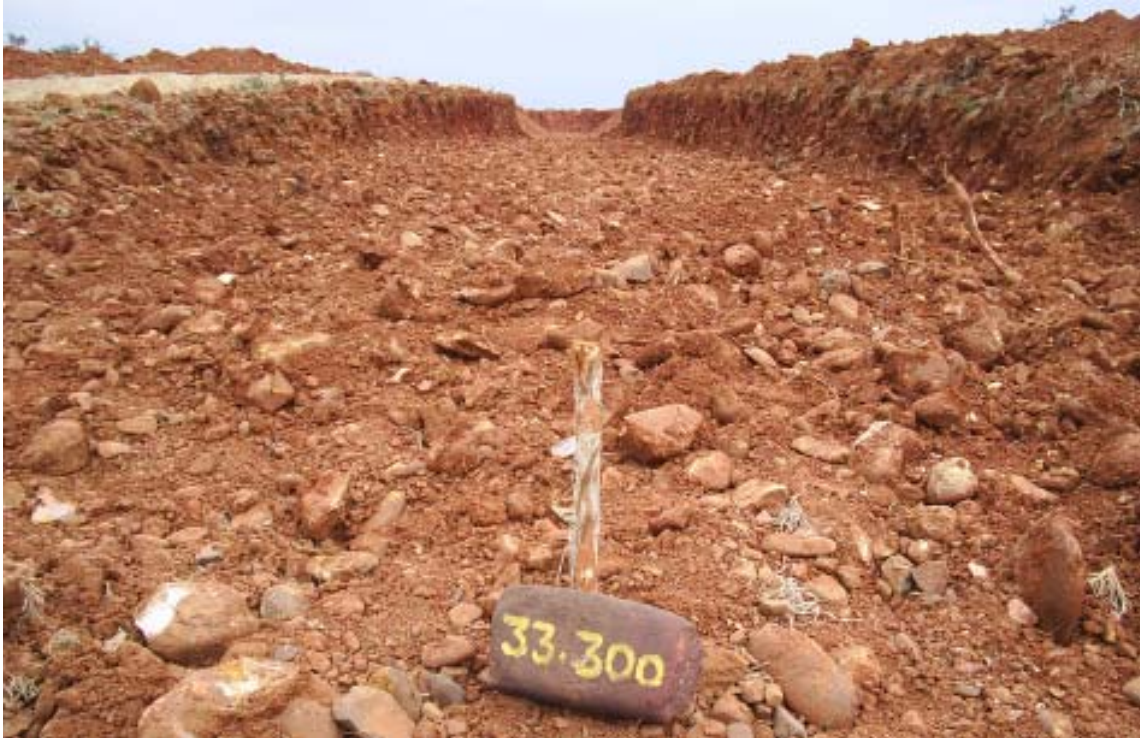
Plate.1. Telugu-Ganga Canal inside the Yerraballi Forest Block near the Sri Lankamaleswara WLS. Canal stopped after 130m from this point since action taken by the APFD. 33.300 marks the length of the canal (in km) from its origin.

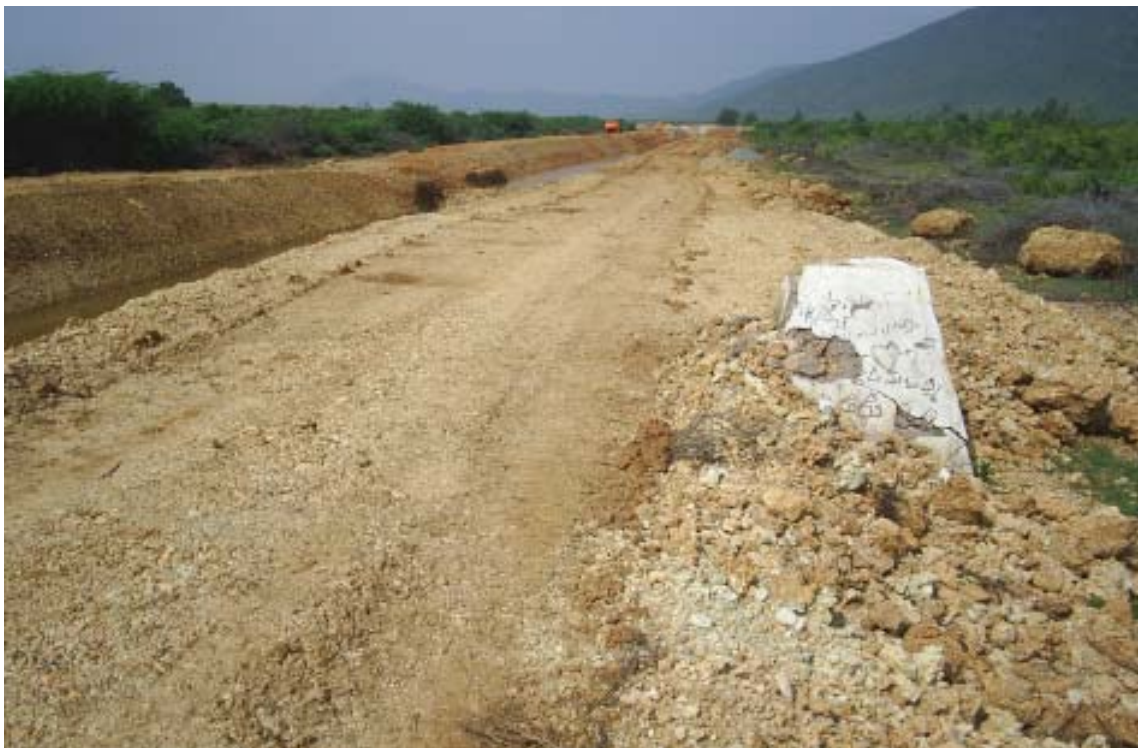
Plate.2. One of the Forest cairns destroyed in the Sri Peninsula Narasimha WLS boundary. Several forest cairns were damaged all along the sanctuary boundary.

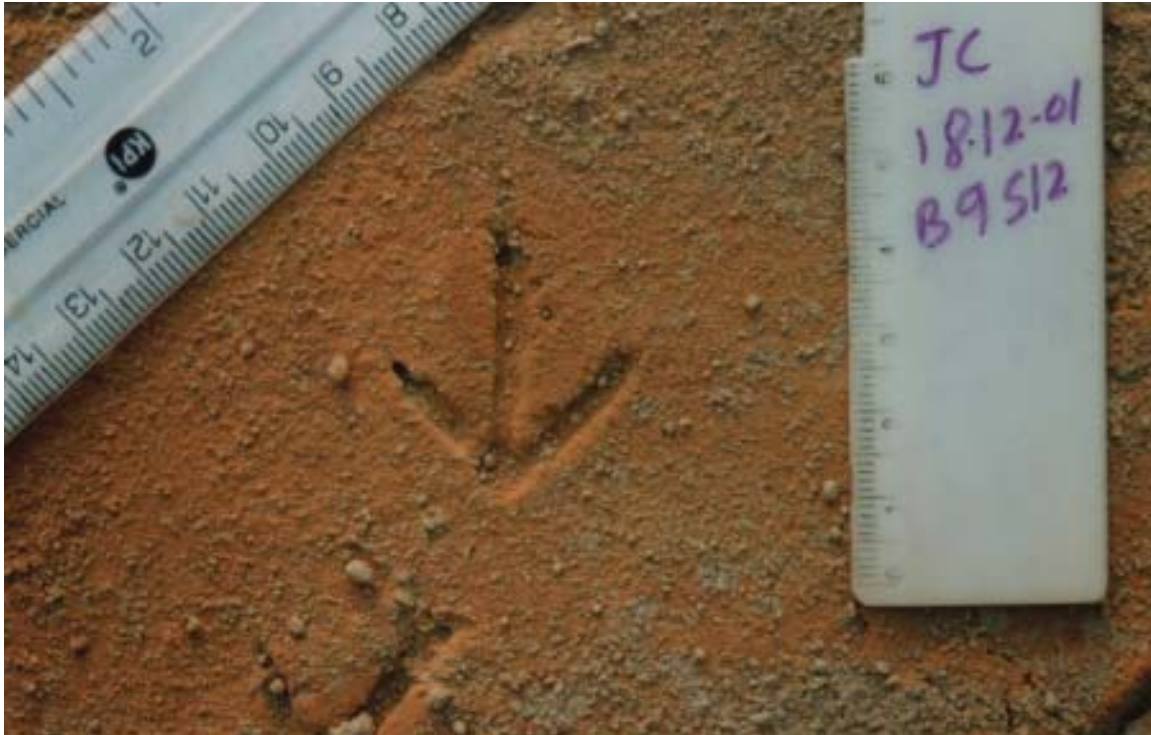
Plate.4. Canal runs through now in the very place where the Jerdon's Courser was recorded in the Yerraballi Forest Block near the Sri Lankamaleswara WLS. Note that the GPS points B9S12.

right canal which is from Kothacheruvu to Yerraballi Forest Block has already destroyed c.15 ha. of potentially suitable habitat of Jerdon's Courser. It has also destroyed one of the places where Jerdon's Courser was recorded in 2001 by means of footprints, direct sightings, and calls (Plate 3 & 4). Apart from this, area cleared for the canal construction near Yerraballi Forest Block previously had c.7 ha of potentially suitable habitat (Plate 5). So in total c.22 ha of potentially suitable habitat of the Jerdon's Courser was lost due to this canal construction in the eastern part of the Sanctuary (Table 1).

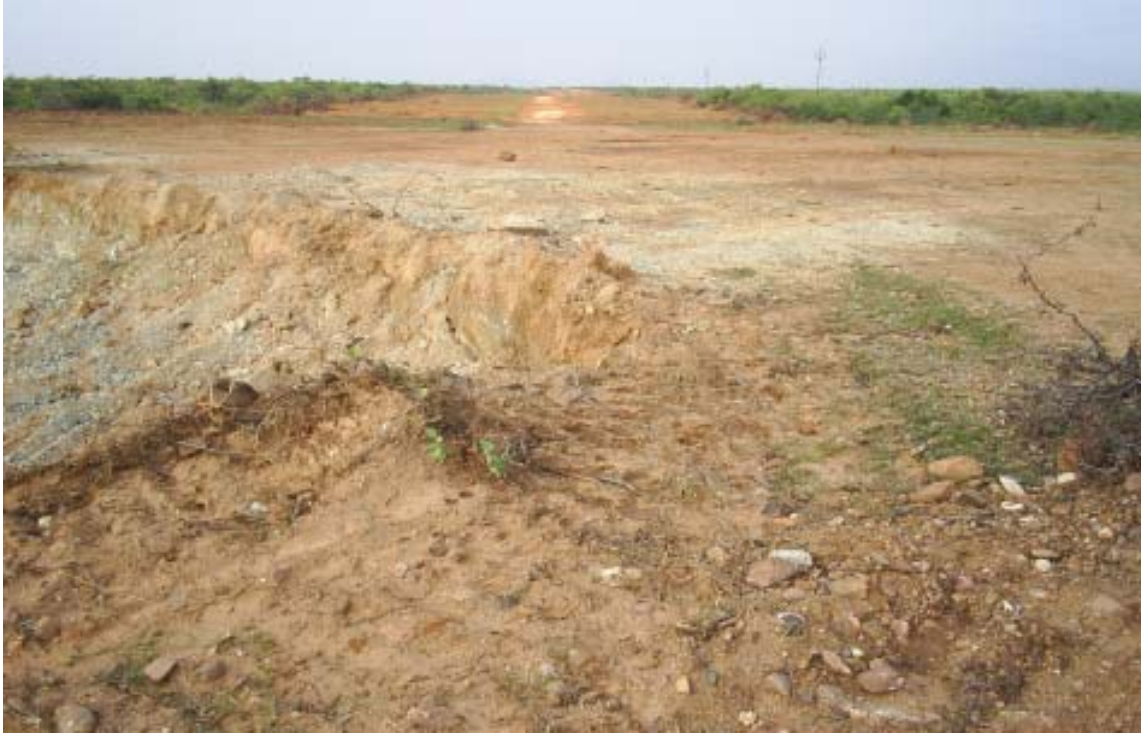
Plate.5. Forest clear in and around the Yerraballi Forest Block near the Sri Lankamaleswara WLS. Nearly 7ha of the suitable habitat of the Jerdon's Courser was lost due to this clear.

3. Cleared area, around the Yerraballi Forest Block, and Muthukur Forest Block should not be allowed to do any agricultural practices. Because there might be a chance of encroachment by clearing more forest areas, so it would be better if these places are patrolled or monitored continuously.

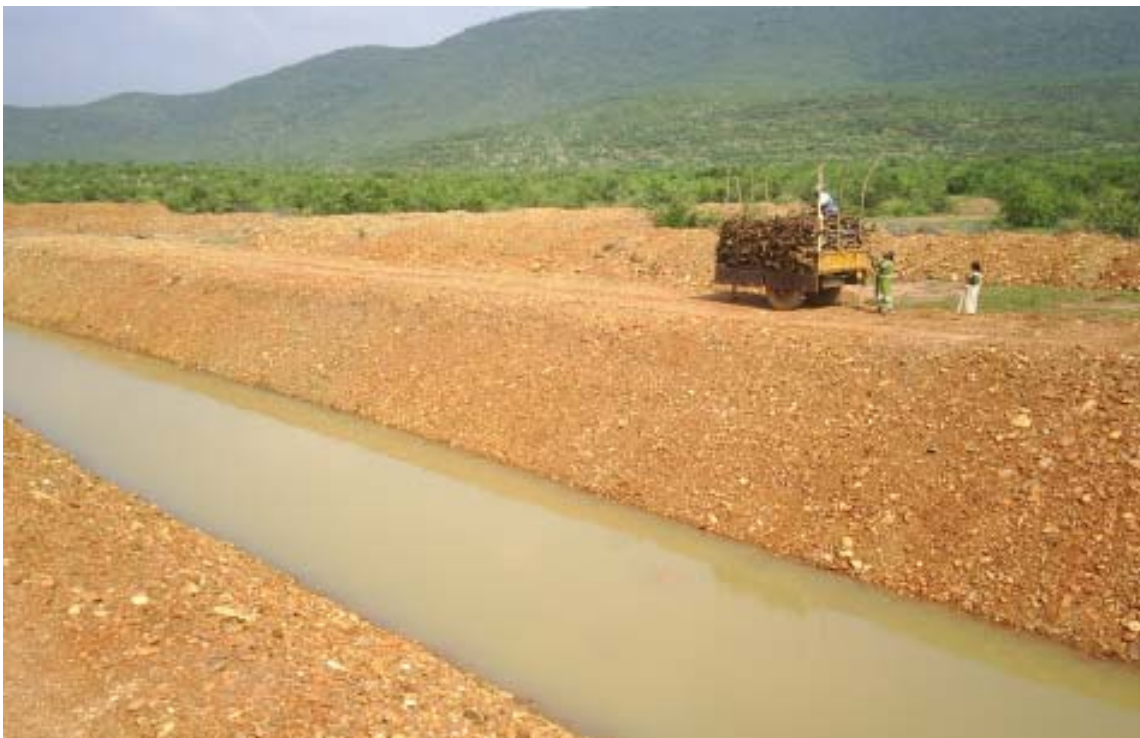
During our recent survey near the construction site of the canal it was observed that illicit woodcutting was rampant (Plate 6). Roads were prepared not only along the canal route but also from the main roads to the canal. This is mainly to access the canal site from the main road for bulldozers and excavators. Invariably these roads were constructed from the near by villages. This facilitates access for local people to the forest area for unauthorized woodcutting, mainly by tractors and bullock carts. The Sri Lankamaleswara Wildlife Sanctuary is also known to have Red sanders

Plate.6. Roads along the Telugu-Ganga Canal would pave way for more illicit woodcutting in and around the Sanctuary area.
